PBY Catalina

Walk Around

By William Scarborough

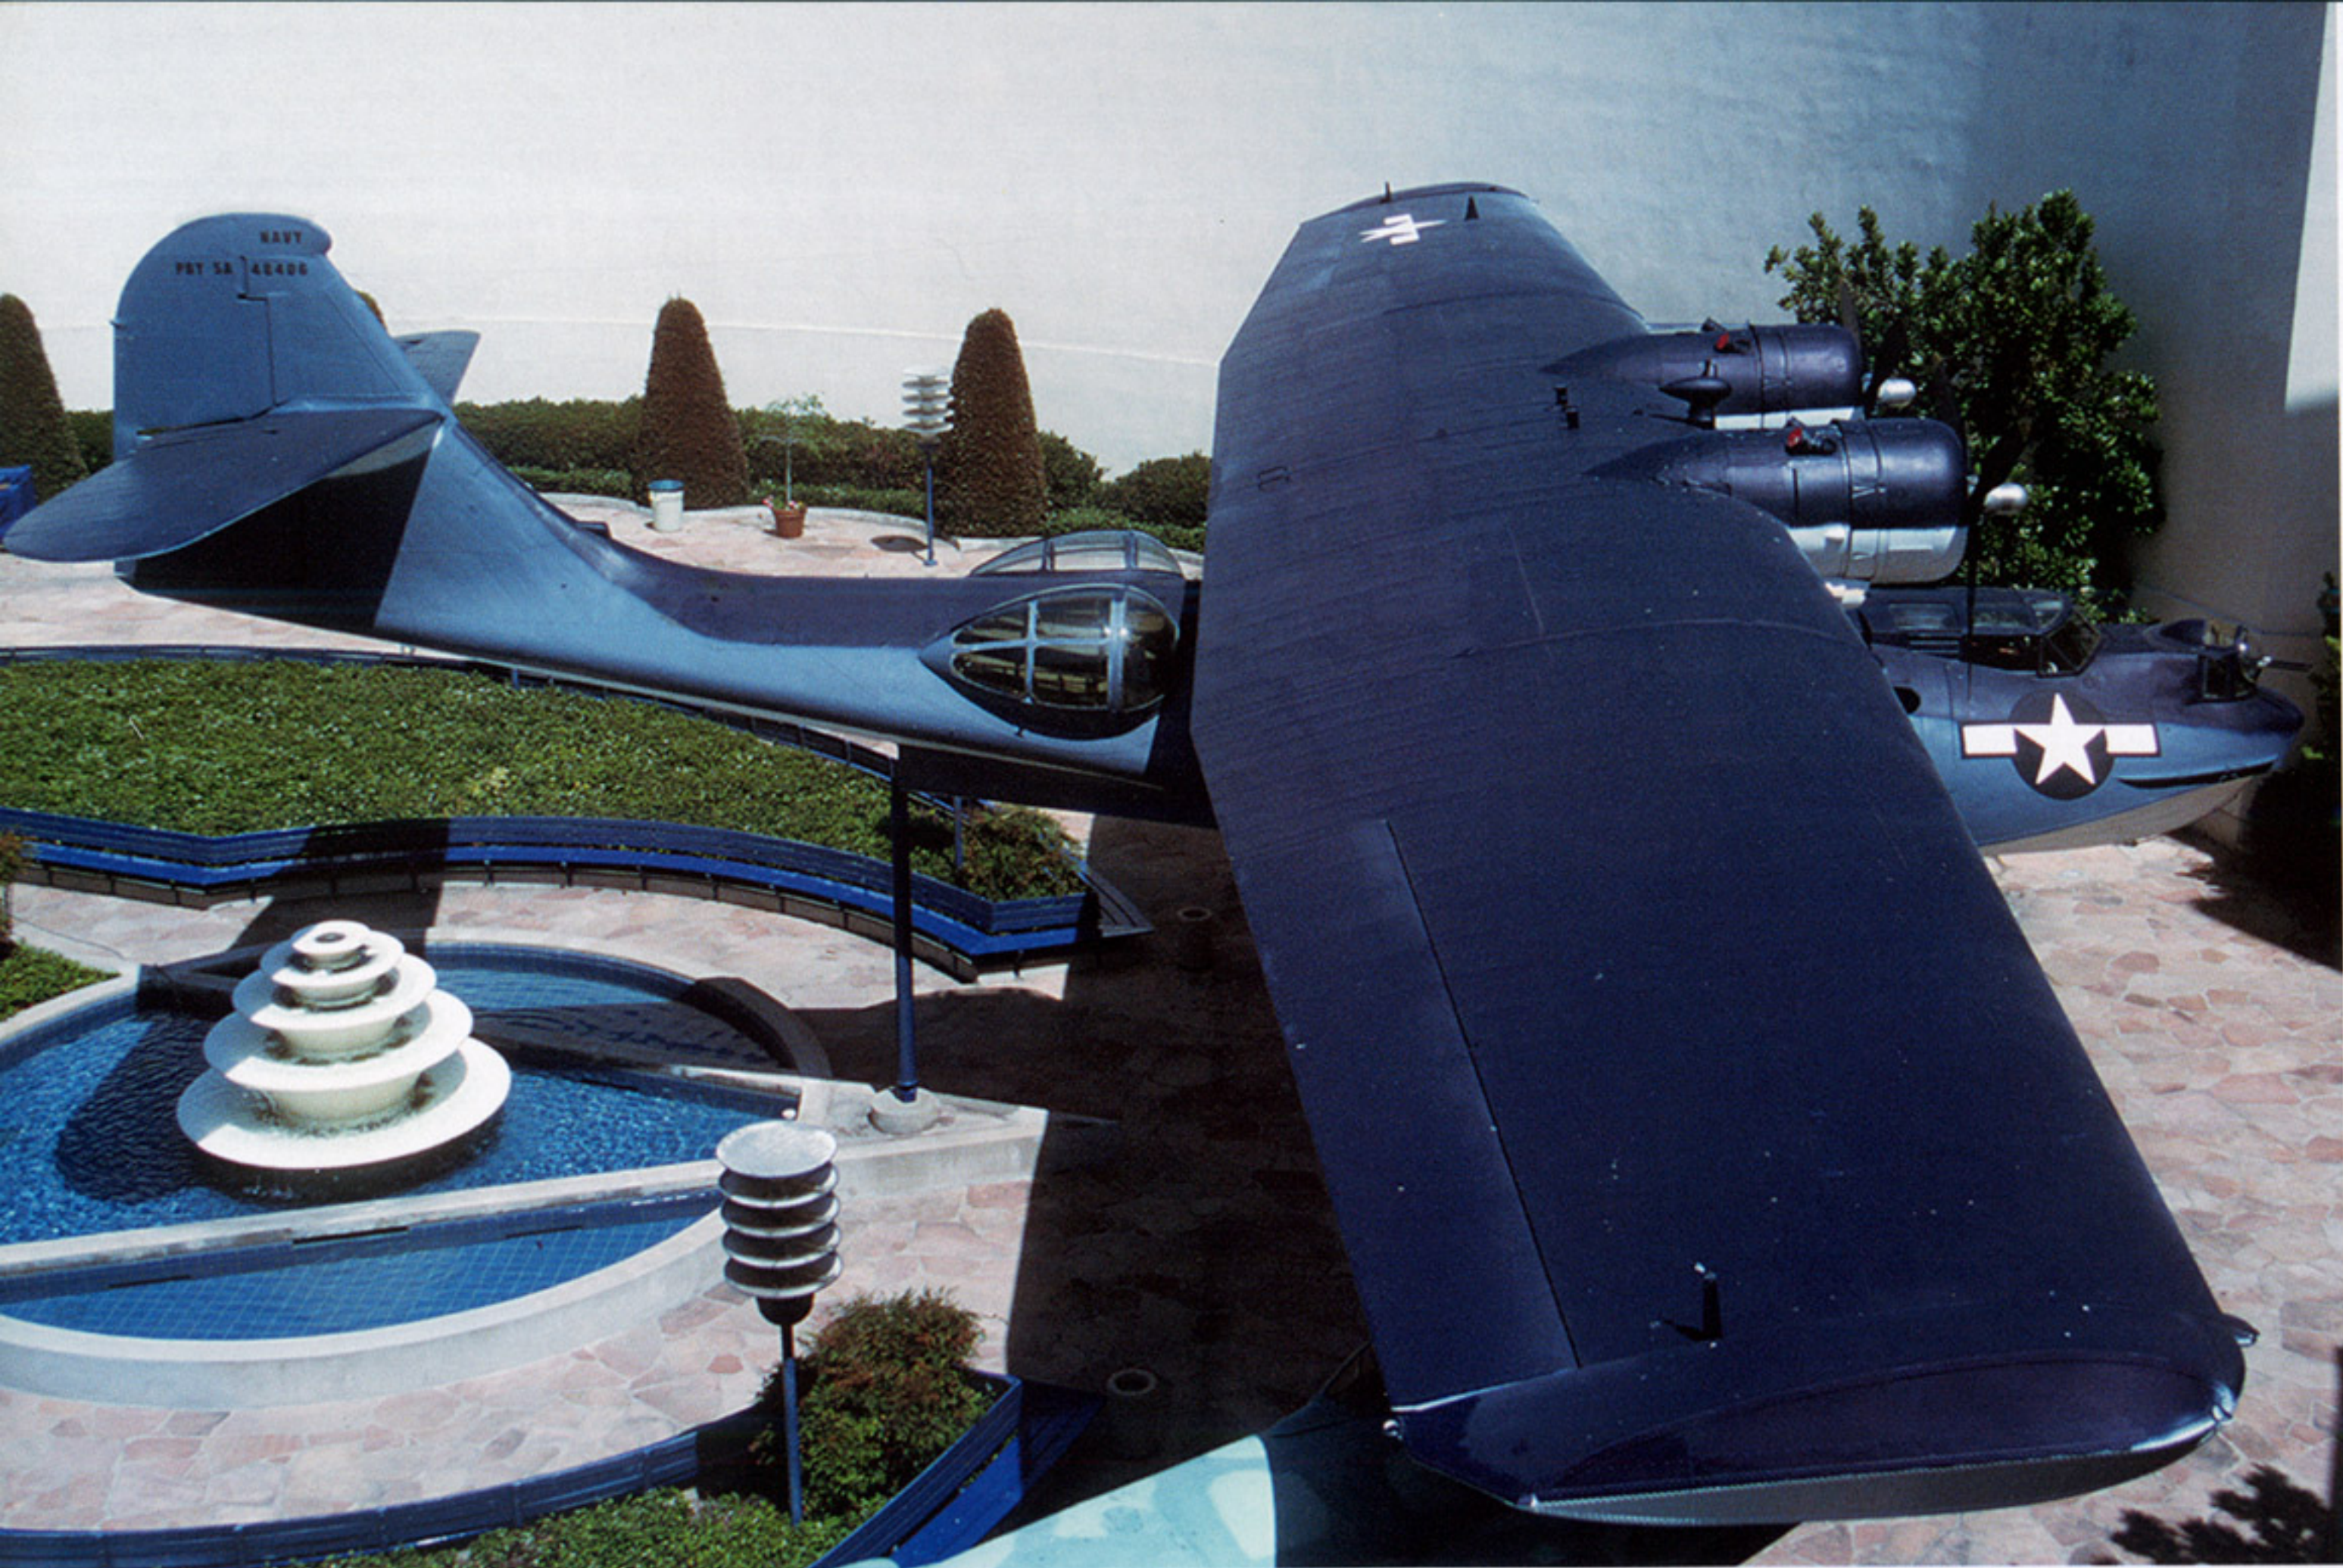
The restored PBV-5A Catalina at the San Diego Aerospace Museum is mounted on a pylon in the museum center court. From above, there are a number of details that are rarely seen including the wing tip antenna posts, wing tip lights, and tops of the engine nacelles. This PBV-5A carries a teardrop Automatic Direction Finder (ADF) antenna mounted on the upper wing between the engines. (Mark Aldrich)

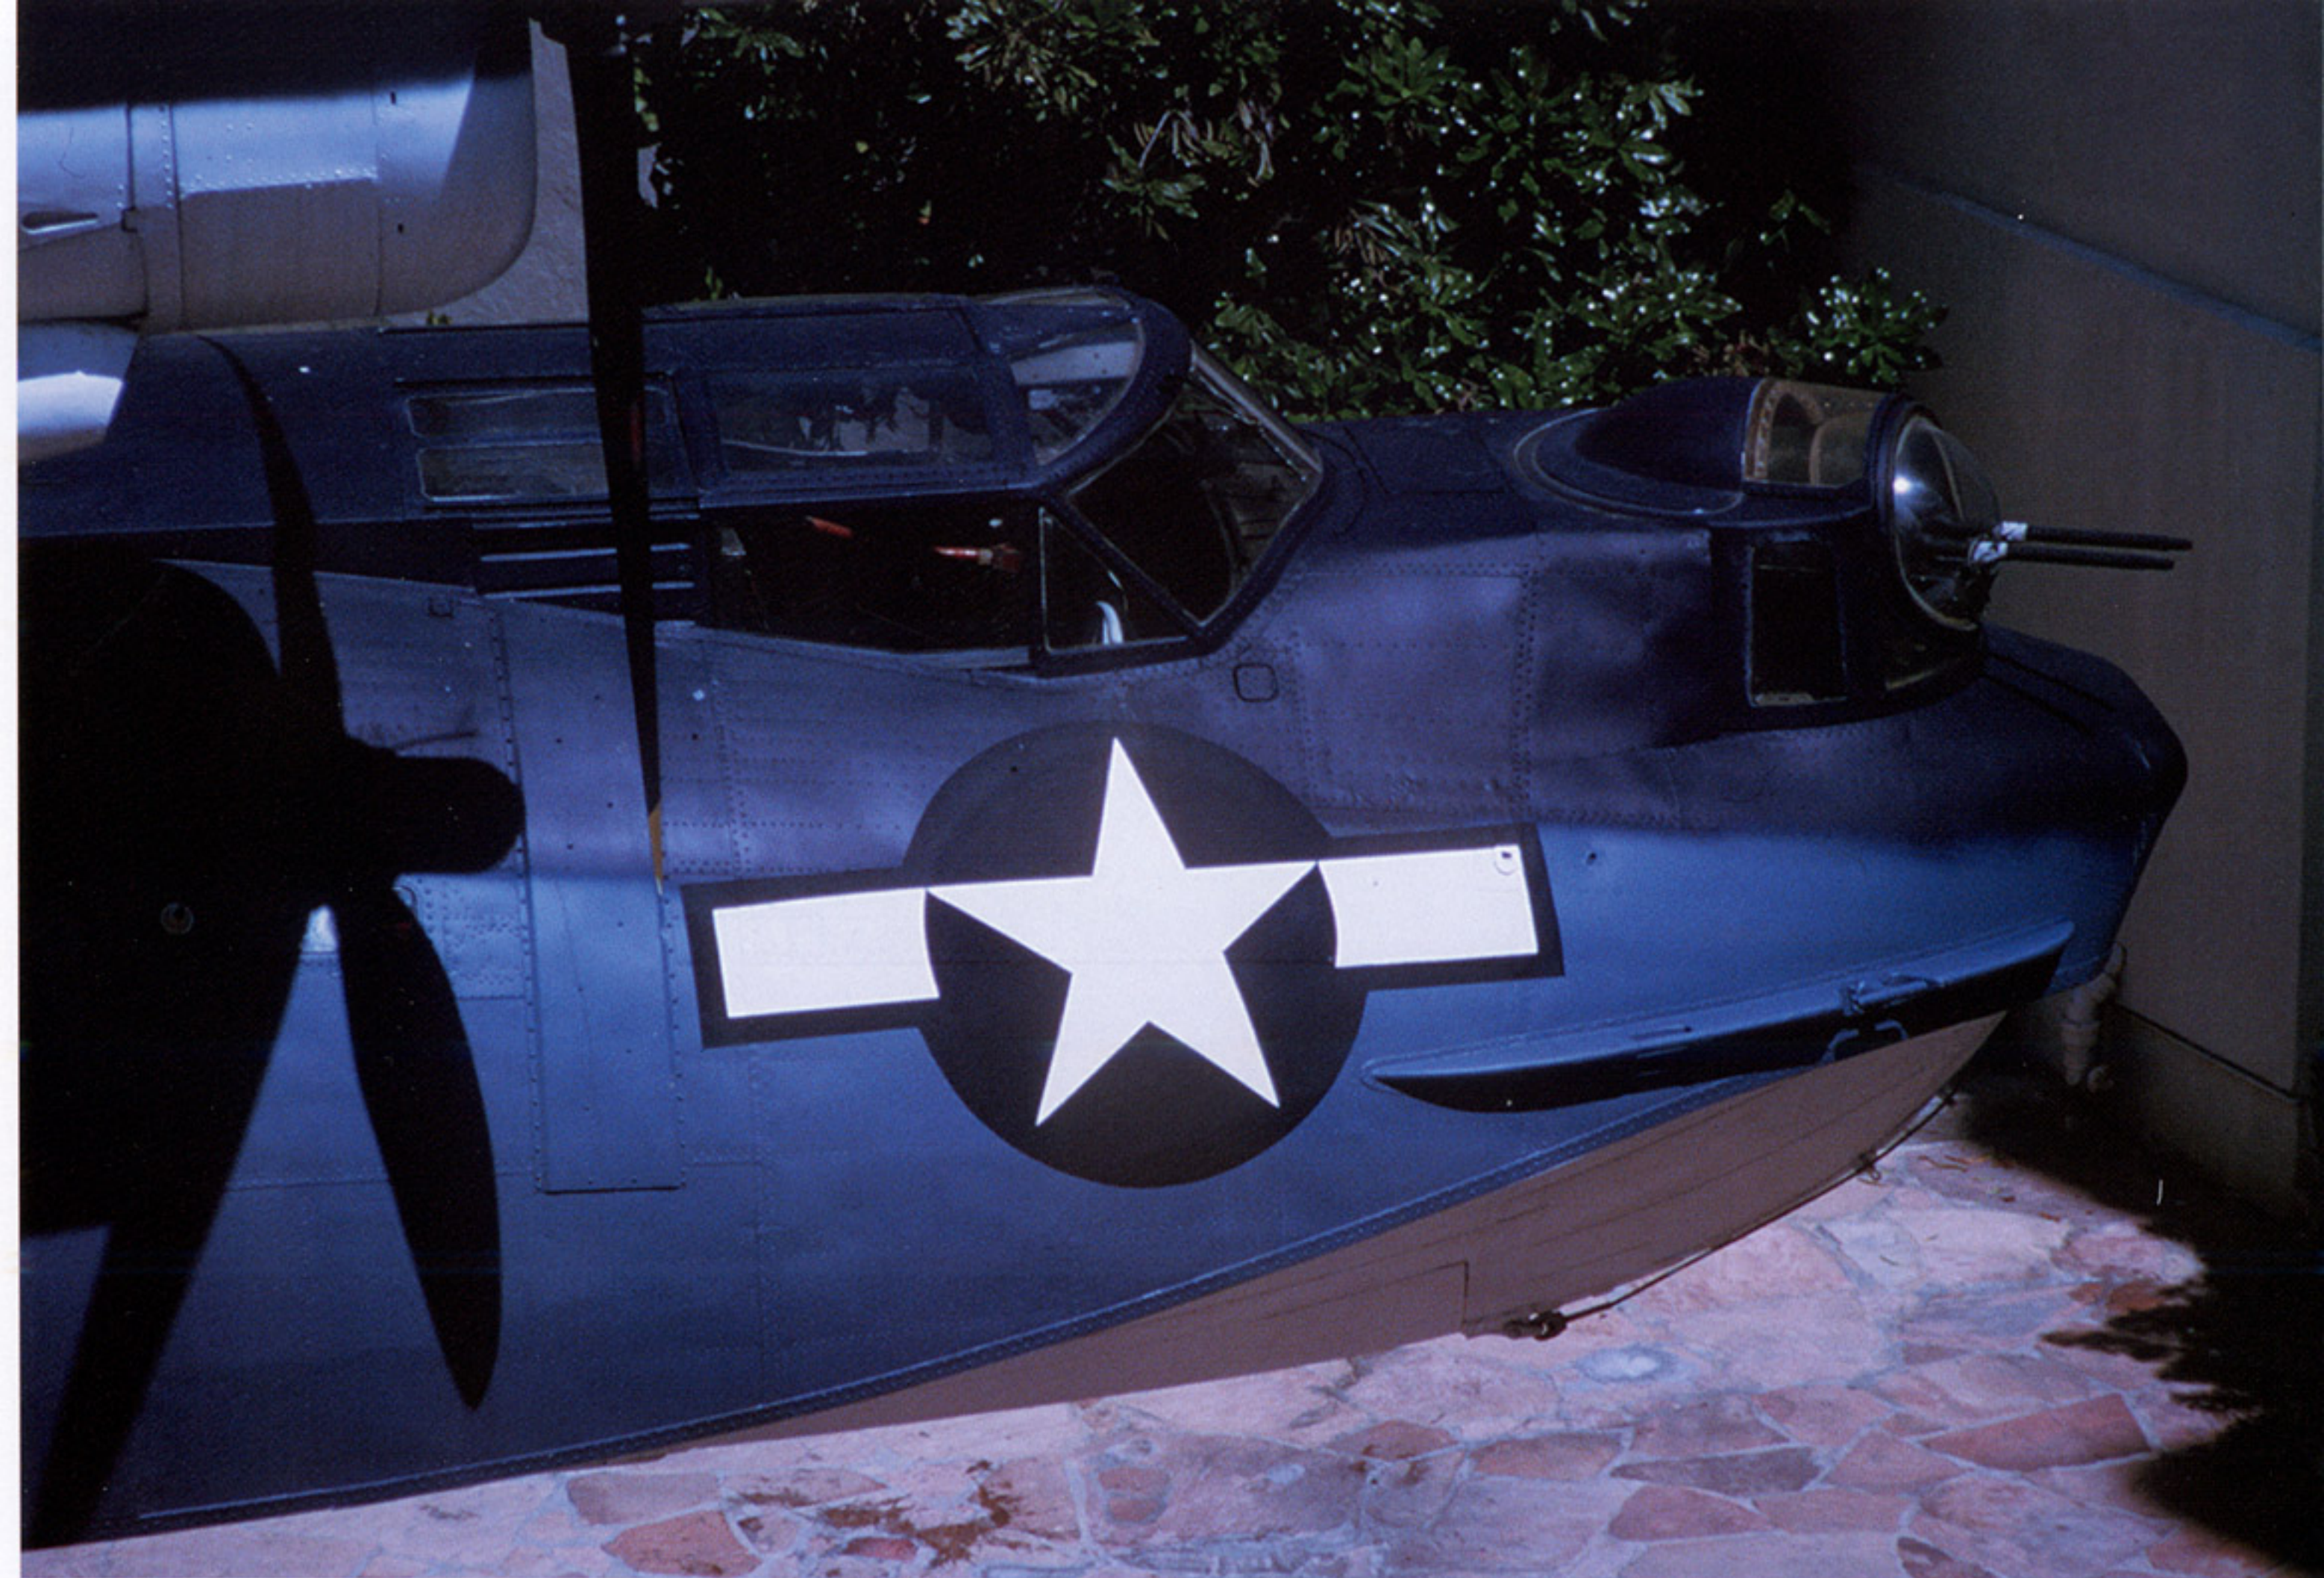
The side windows in the cockpit canopy opened and slid backward on tracks in the fuselage side for opening. The chine rail, with its mooring cleats, was used by the crew to stand on while anchoring or mooring the PBY to a buoy. The two upper canopy windows also opened, sliding to the rear. The small U shaped panel in the upper right side of the insignia bar is a pull-out step, used by the crew for climbing up on the fuselage from the chine rail. (Mark Aldrich)

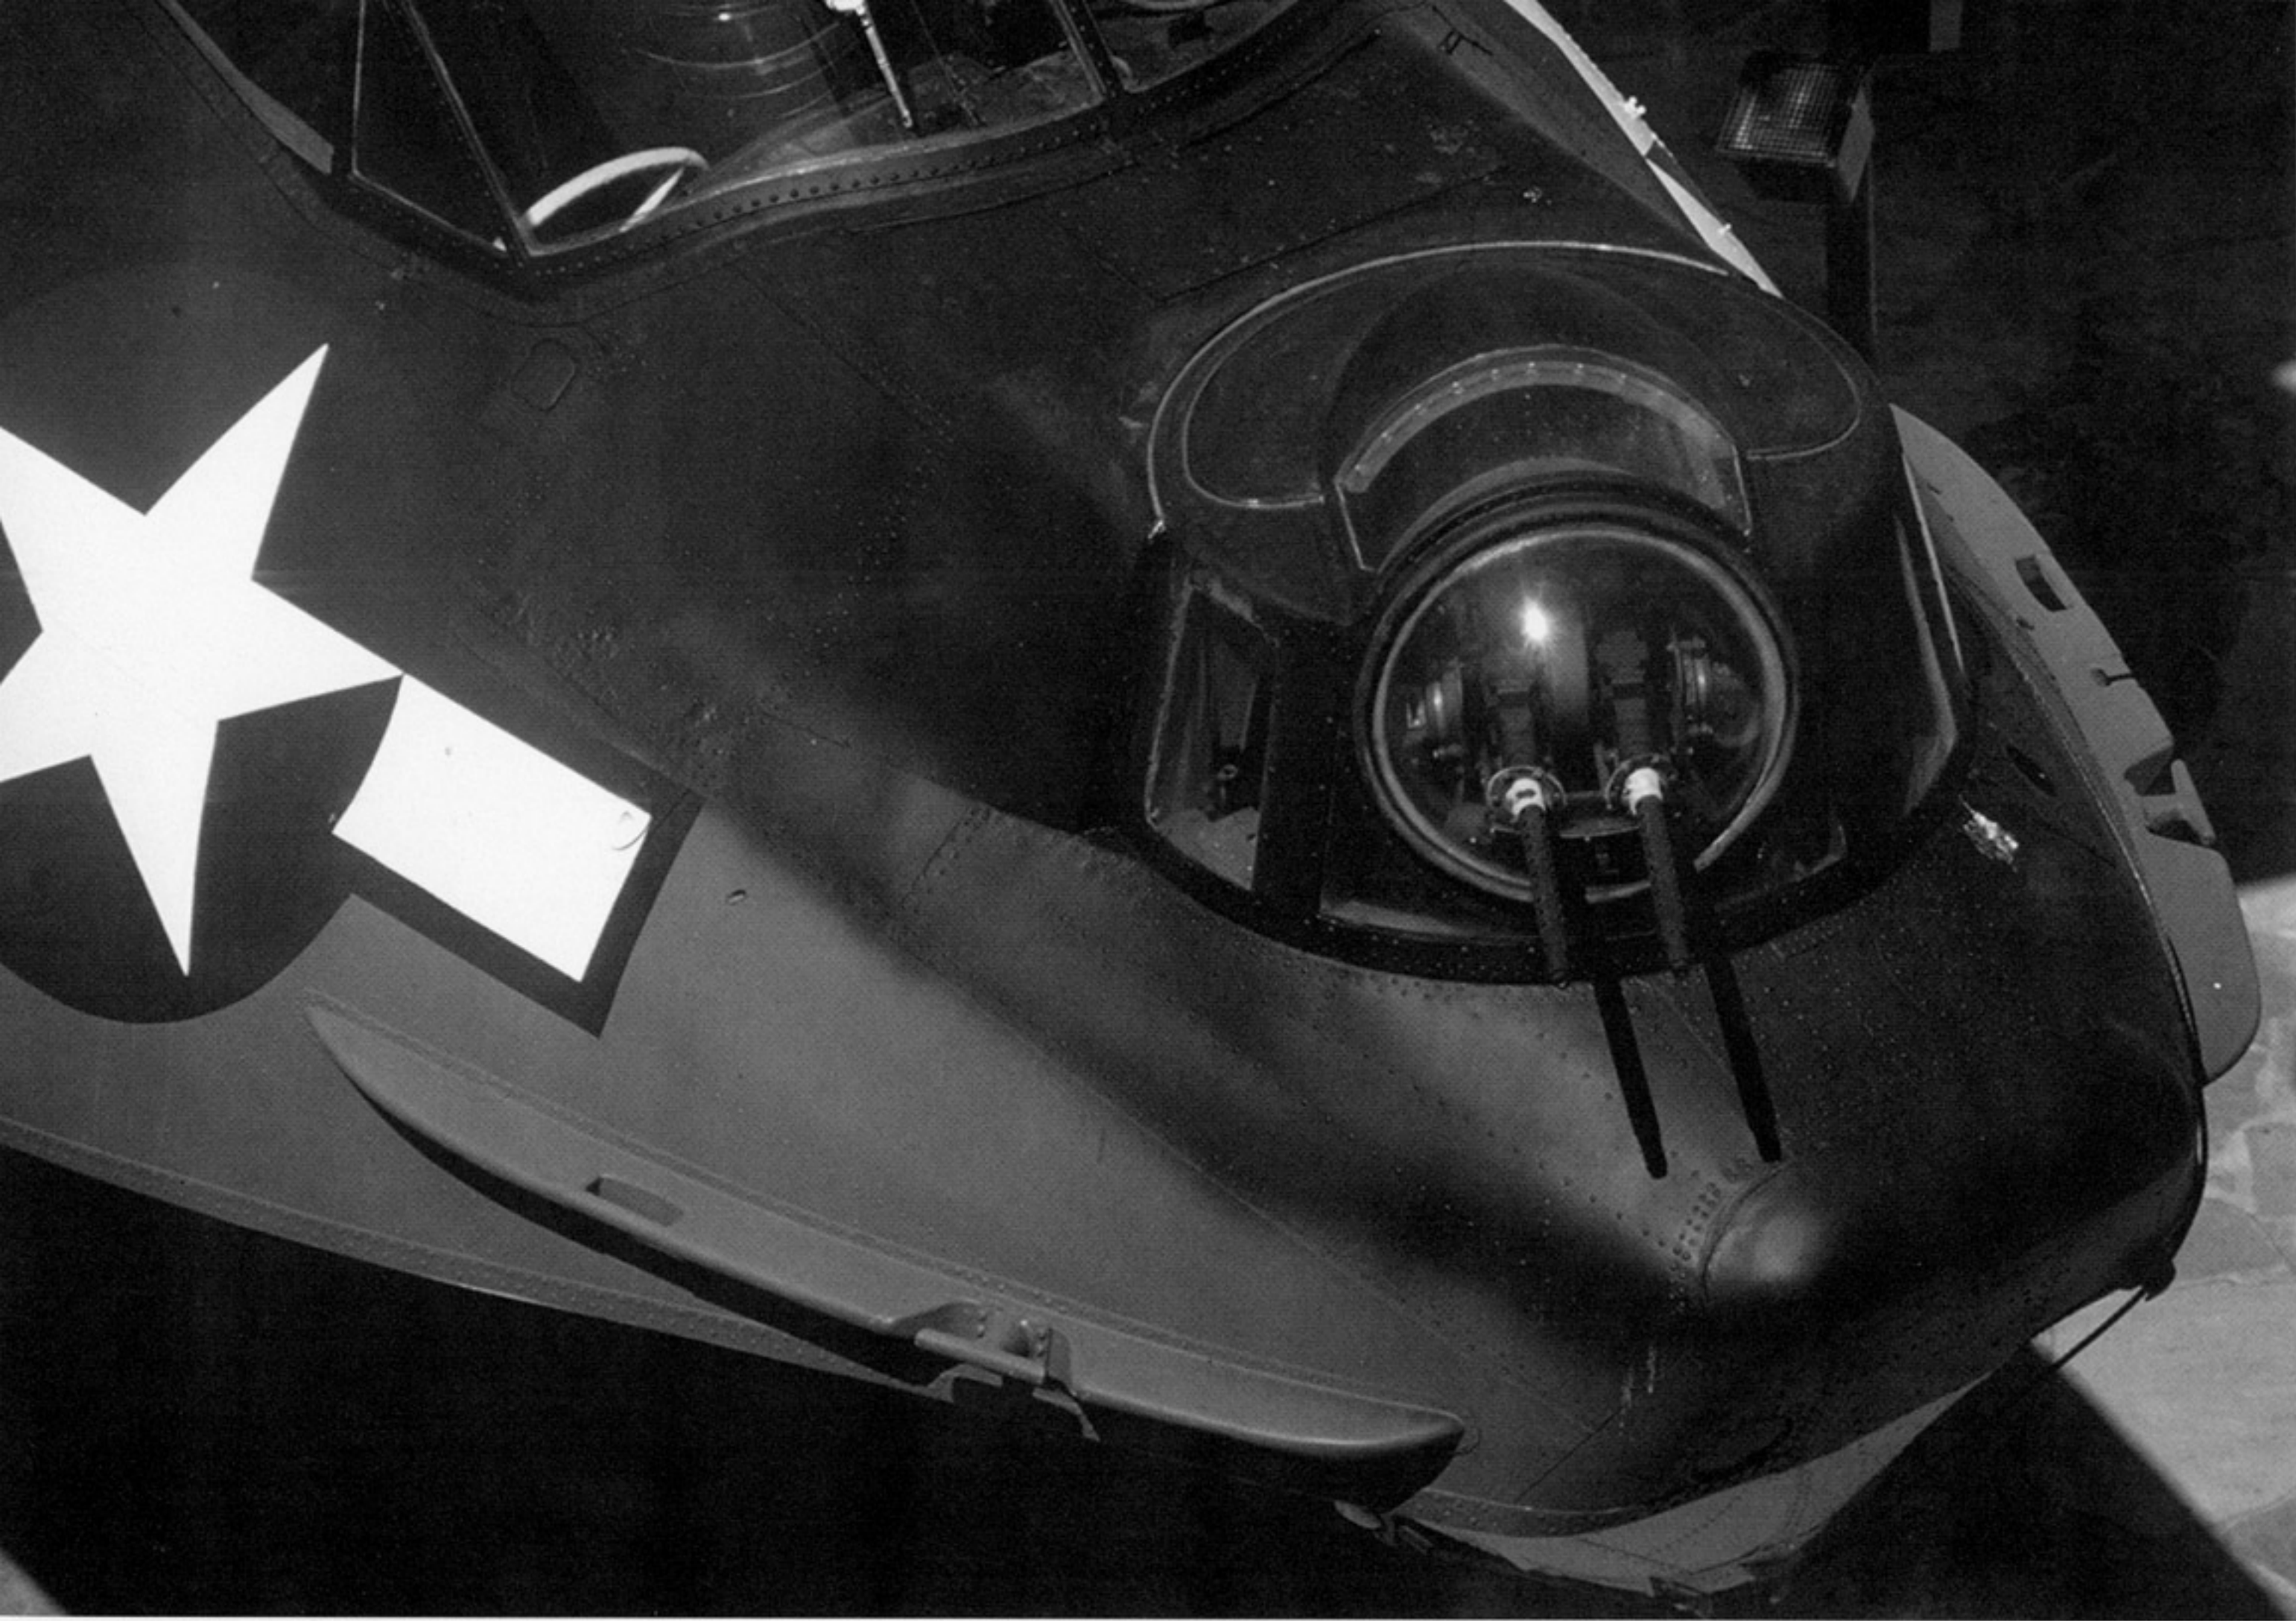
The PBX-5A Catalina on display at the San Diego Aerospace Museum carries the late war "Eyeball" twin .30 caliber machine gun bow turret. This enclosed turret replaced the open single gun position used on earlier PBX variants. Other features visible include the chine rail with its mooring cleats. (Mark Aldrich)

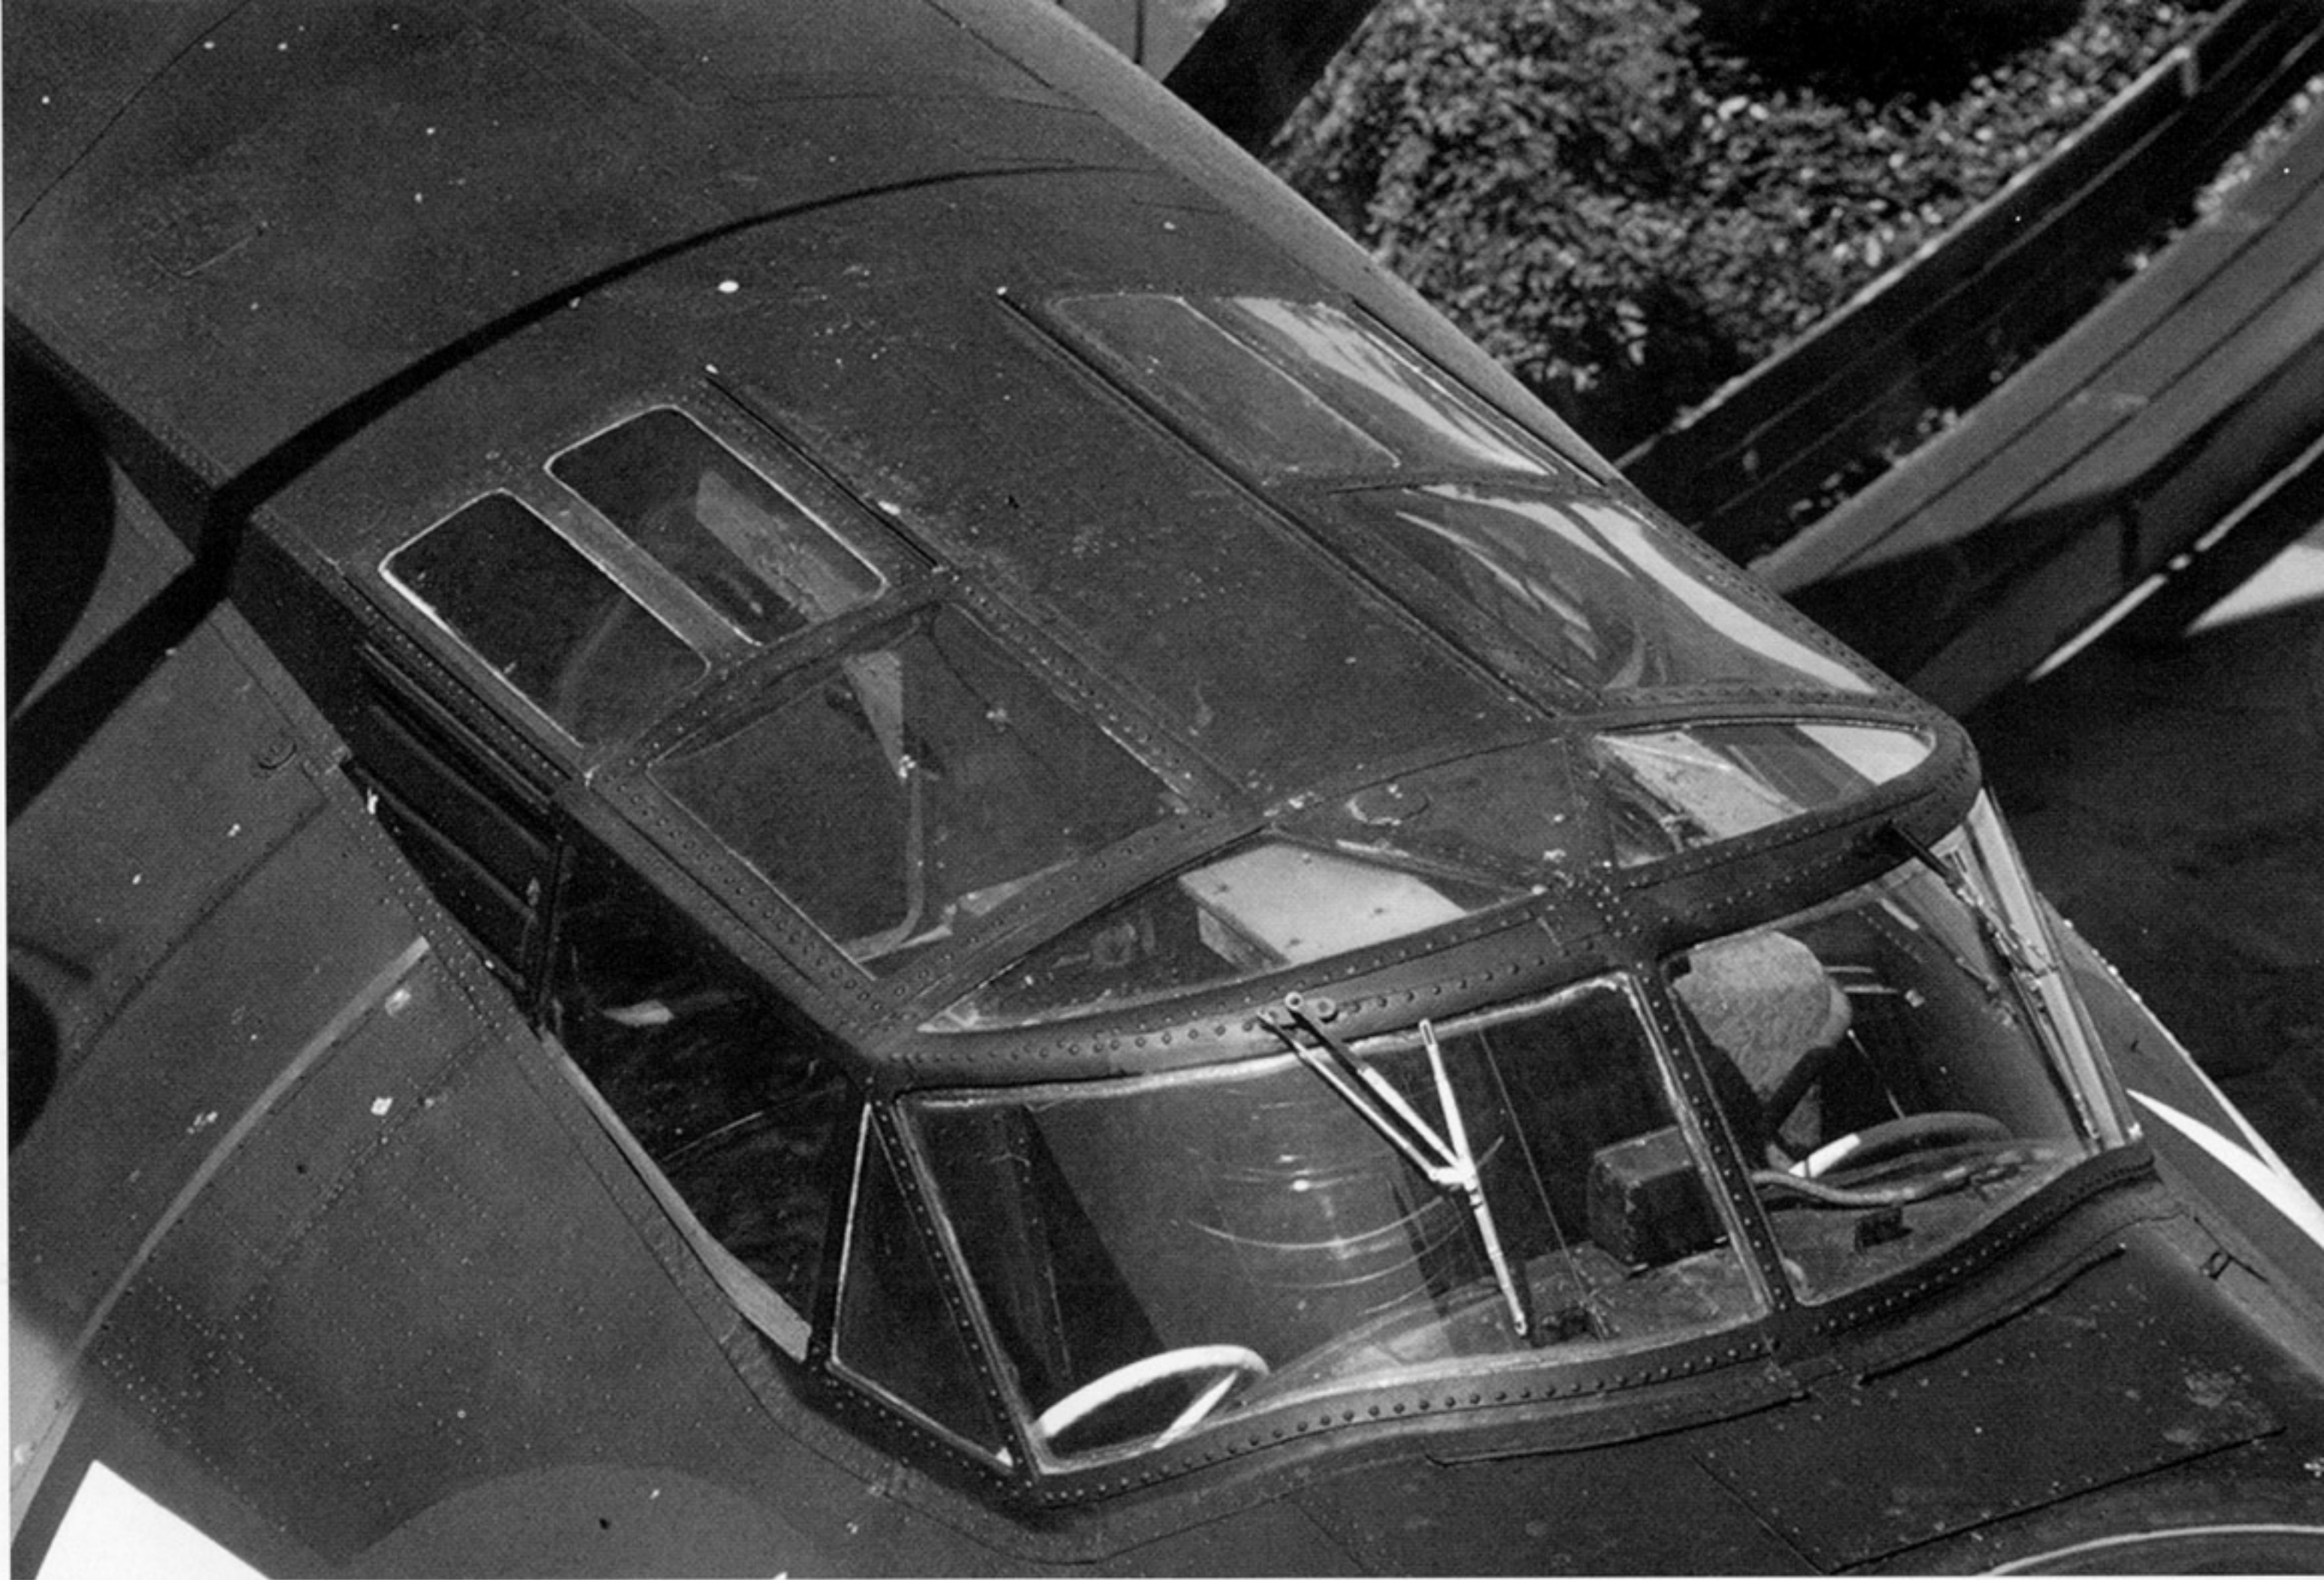
The upper canopy of the PBX-5A featured rear sliding windows on both sides that doubled as upper fuselage escape hatches. The PBX used a wheel mounted on a control yoke for aileron and elevator control. There were windshield wipers installed on both sides of the windscreen to assist in clearing away spray during water takeoffs and landings as well as in rain and during deicing. The side windows on both sides of the cockpit also opened, sliding to the rear. (Mark Aldrich)

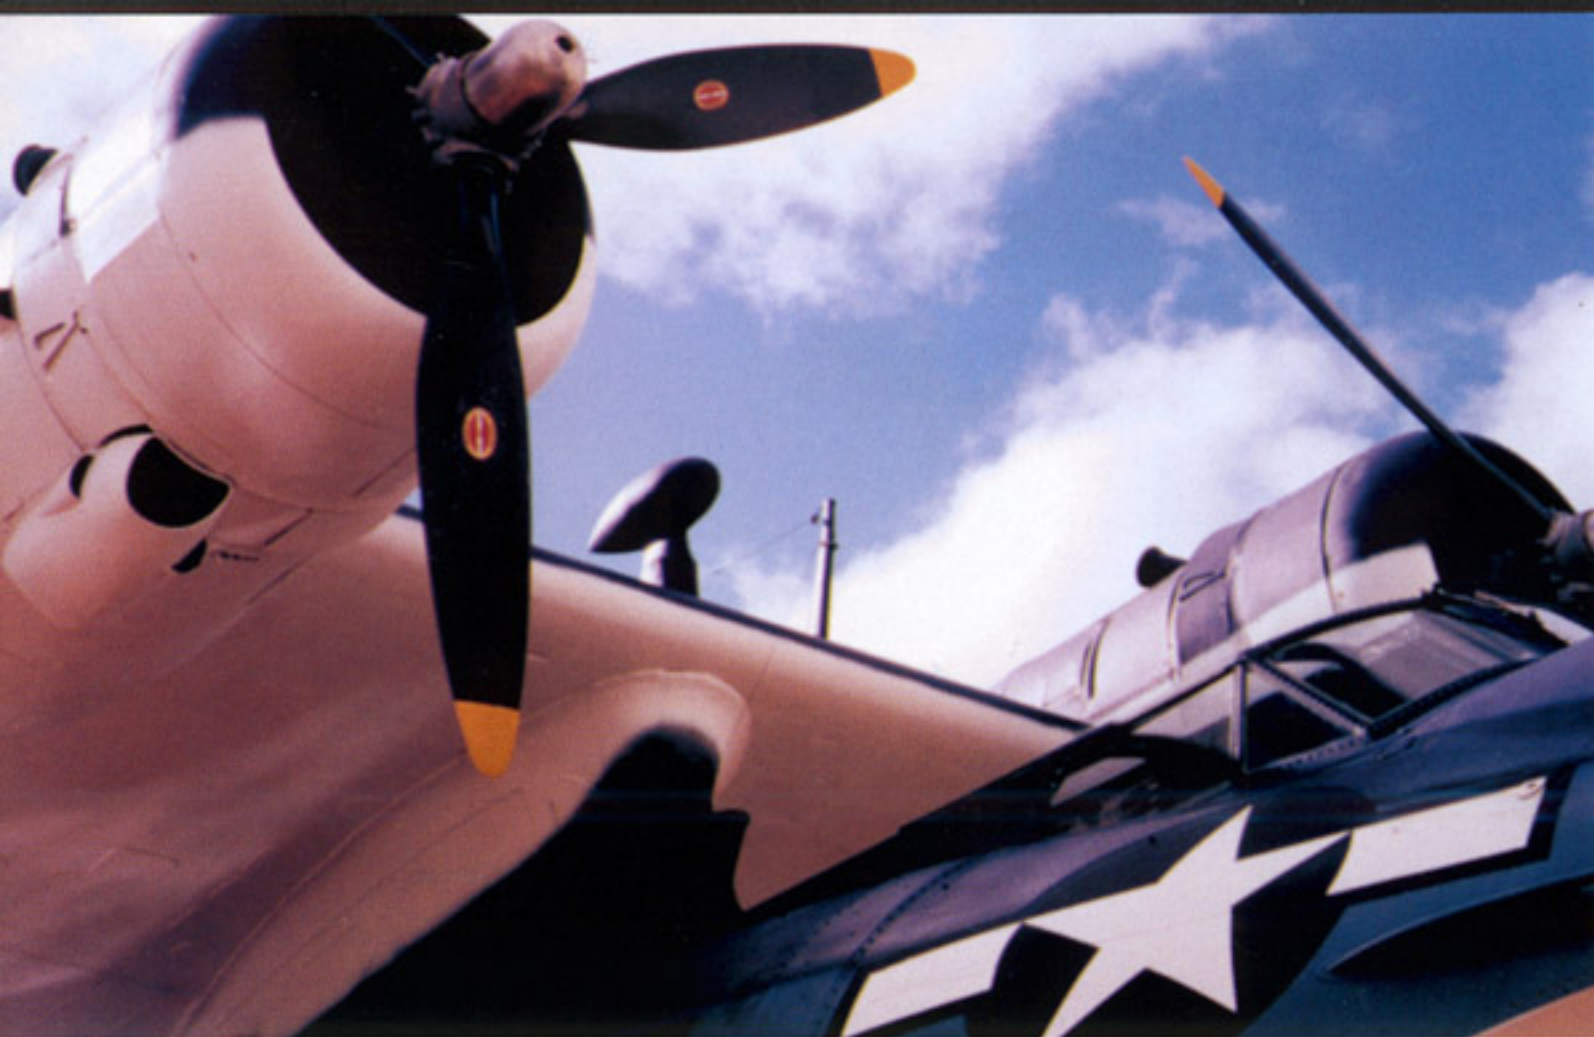
The PBY-5A at the San Diego Aerospace Museum is mounted on a pylon in the center Court. Visible are the cockpit, wing support pylon which housed a mechanic's station, wing center section and engine nacelles. An ADF teardrop antenna housing and antenna lead-in mast for the flat top antenna was mounted above the wing center section. (Richard Dann)

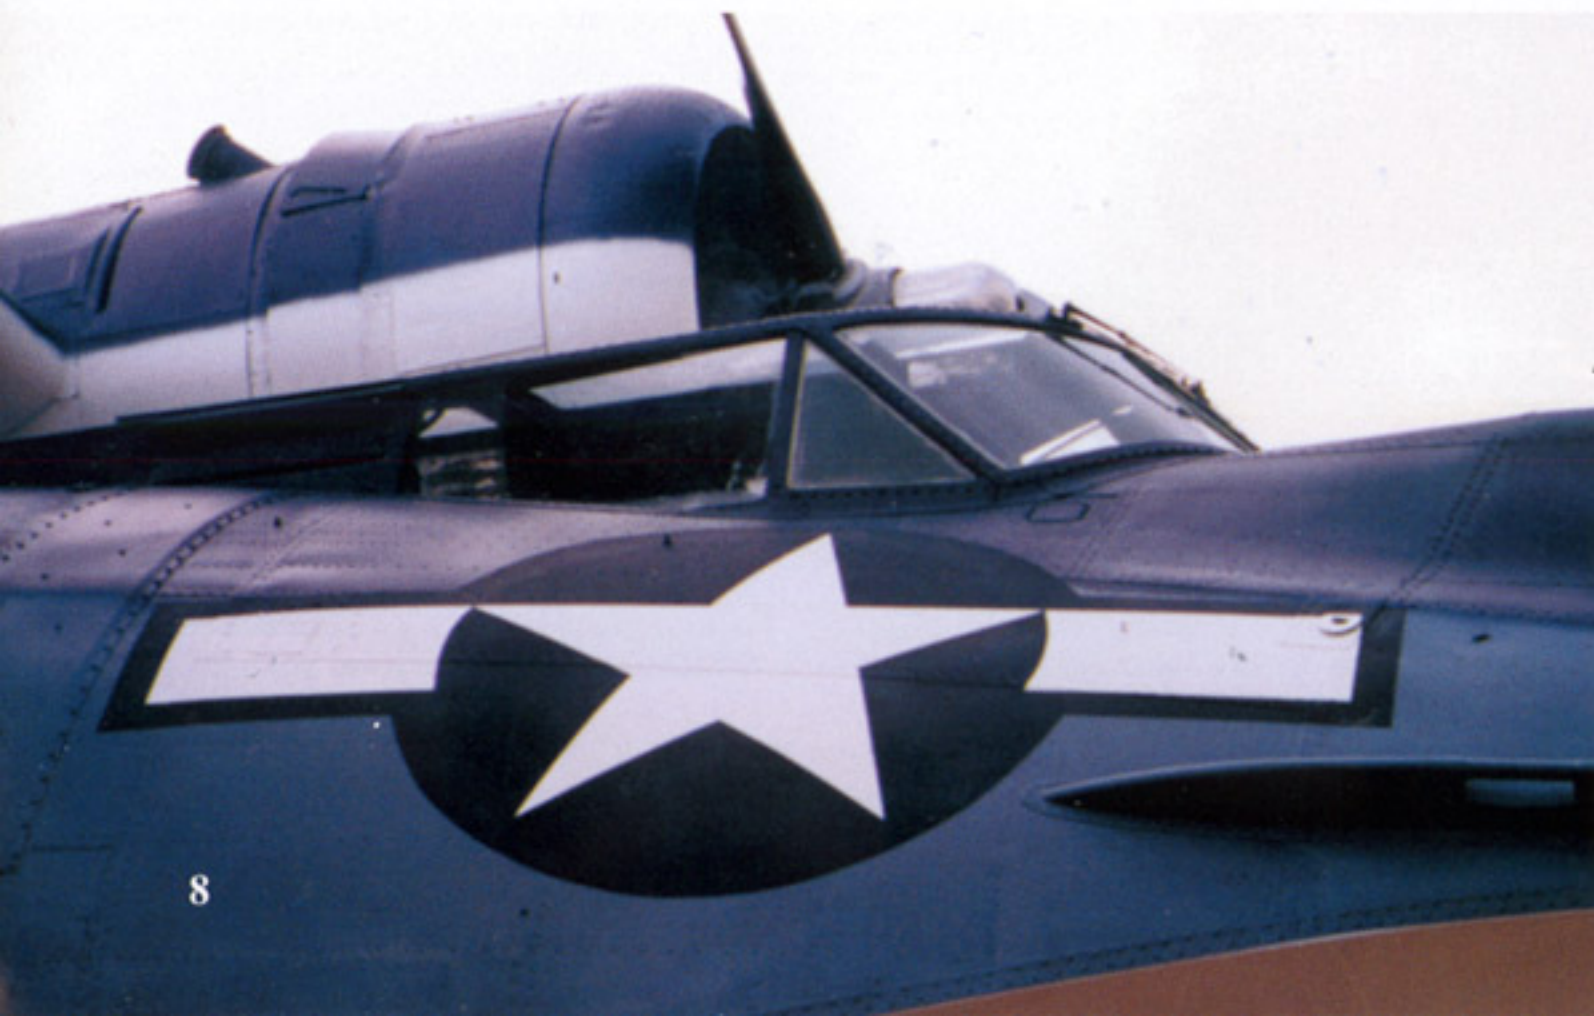
The starboard bow area of the SDAM BY-5A. From left: fuselage ice shield, which was a metal doubler to prevent damage from ice thrown from the propellers during icing conditions. The small vent at the bottom corner of the windshield can be cranked open from inside the cockpit. A pull out step is located at the upper right corner of the insignia. (Richard Dann)

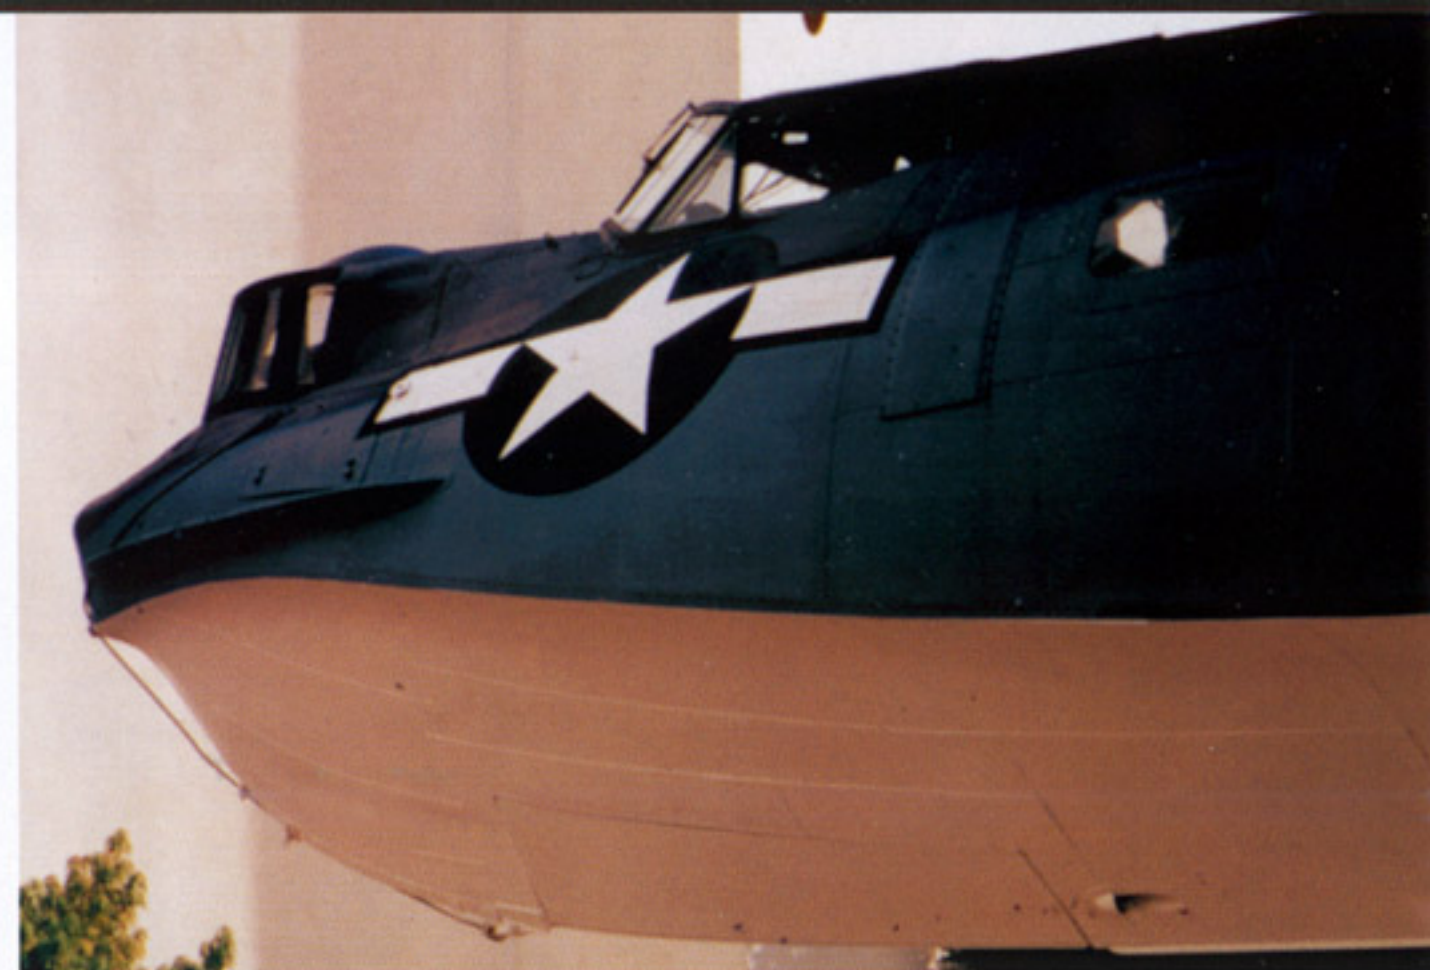
The port bow area of the SDAM PBY-5A reveals the windshield and wipers, bow gun turret, chine rail (used by the crew when anchoring and mooring), anchor stowage compartment door, nose wheel compartment doors and, to the rear of the door, a vent for water drainage after a water takeoff. (Richard Dann)

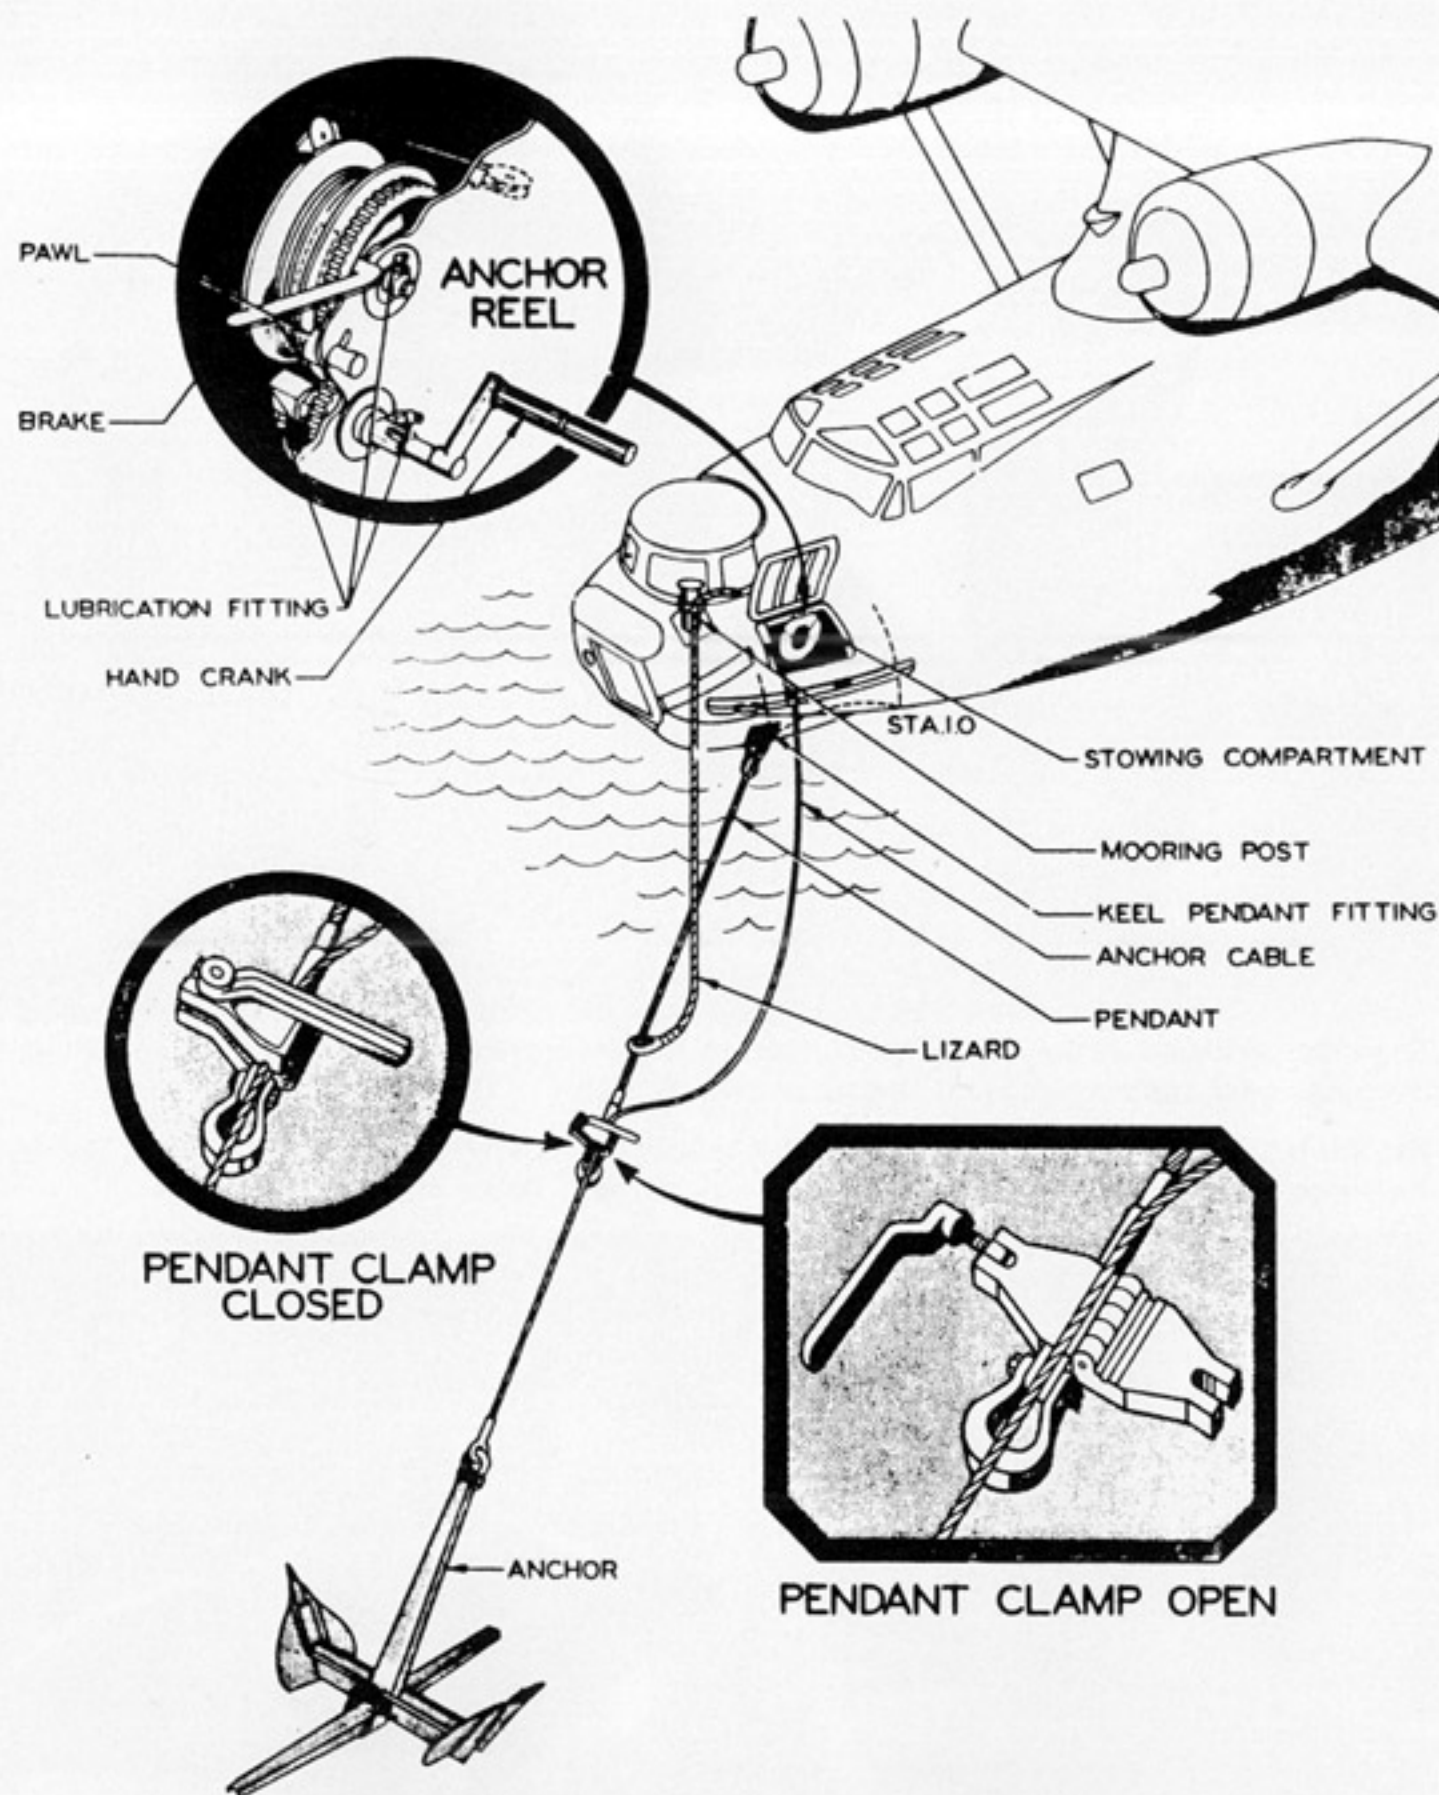
Anchor gear details and usage. The pendant clamp was used to transfer the anchor load from the anchor cable to the bow pendant, which was permanently attached to the keel. The Lizard line was used to retrieve the pendant when reeling in the anchor cable. The mooring post was removable and was not always used. The detachable hand crank was used for the anchor, for manually cranking engines and for lowering or raising the wing tip floats when electric power not available. (USN Manual)
